FACILITY AUDIT SCHOOL DISTRICT OF MELLEN AUGUST 2023

PREPARED BY:
CESA 10 Facilities Management
725 W Park Avenue
Chippewa Falls, WI 54729
888-947-4701
<http://facilities.cesa10.org>

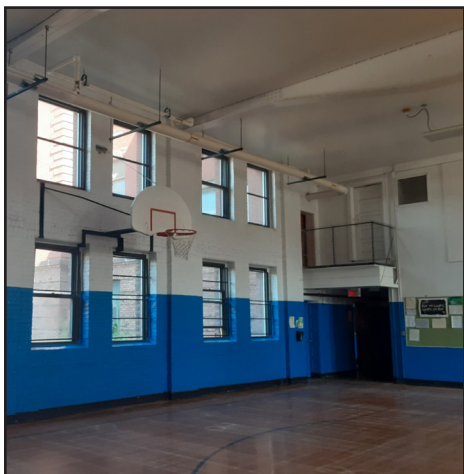
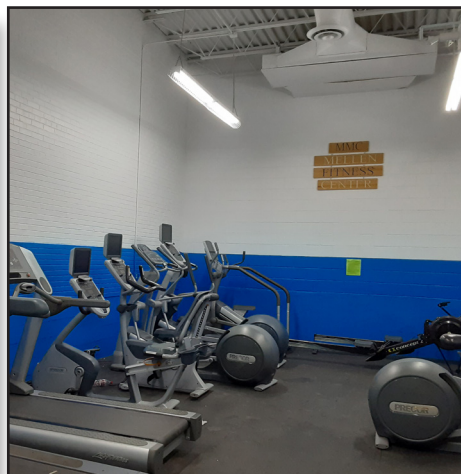
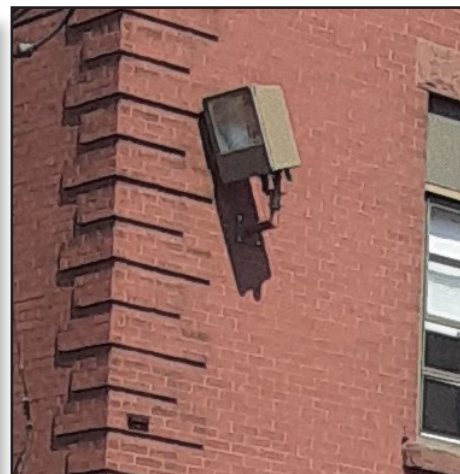
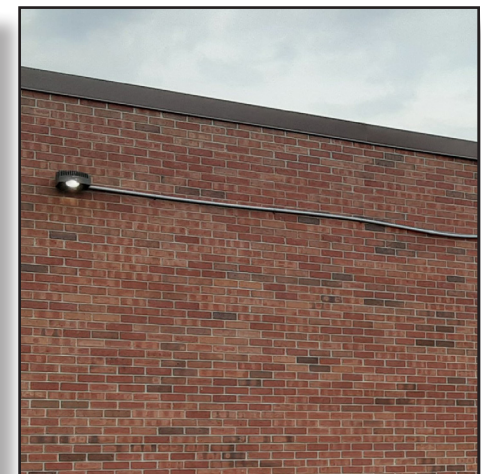
Facility Improvement Measures School District of Mellen			Project Recommendation Priority Order						
			<2 yr=10 3-5 yr= 7 5-10 yr= 3 10+ yr= 0	High=10 Med=5 Low=0	Poor =10 Ave =5 Great =0	<2 yr=10 5 yr= 5 10 yr= 2 20 yr= 0	Priority	<\$10K=1 <\$100K=2 >100K=3	
Building System	General Description	Recommendation	Useful Life	EHS Concern	Func. Cond.	ROI	Total Points	Proj. Cost	Cost Est.
Electrical Other	There is an inadequate first responder call system.	The District should install a panic button with an automatic first responder call feature.	10	10	10	0	30	1	\$8,500
Interior Other	Additional gym space, a fitness center, and an emergency community shelter are needed.	The District should consider building a new area to include these features. The City has offered to provide a donated lot (\$200k). A FEMA floodplain relief grant would cover the cost of the building shell (\$1.2M). The District would be responsible for the furnishings and desired amenities (\$800k).	10	9	10	0	29	3	\$2.2 Million

Site Utilities	There is metal halide building-mounted lot lighting.	The District should replace these with LED fixtures for longer run times, decreased operational costs, and increased energy efficiency. It should reduce fixtures as needed.	7	6	10	5	28	1	\$2,200
Site Utilities	The wall-pack lighting is not LED.	The District should reduce fixtures, remount electrical supply conduit, and replace existing lighting with LEDs.	7	6	10	5	28	1	\$9,800

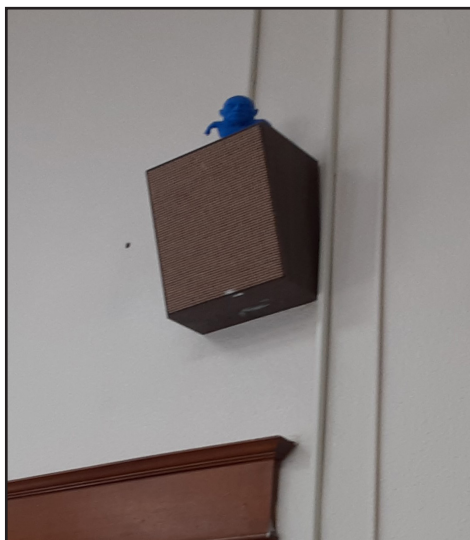
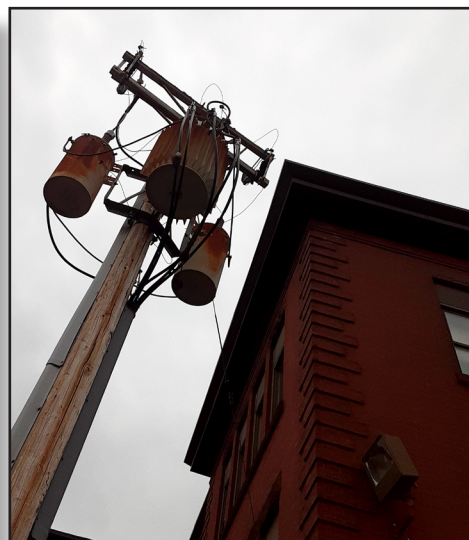
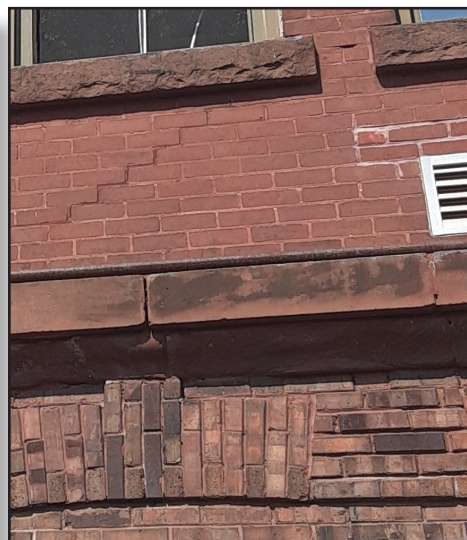
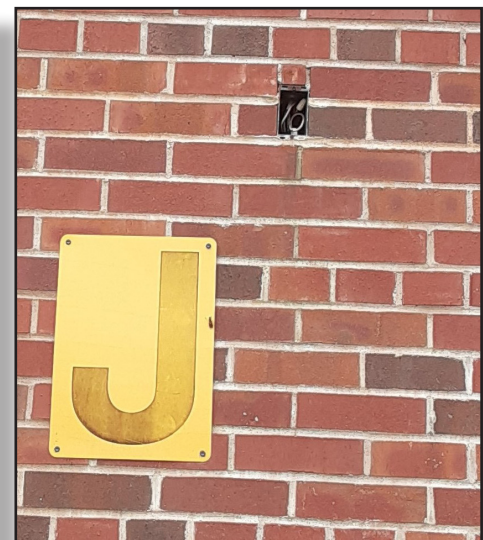
Facility Improvement Measures School District of Mellen			Project Recommendation Priority Order						
			<2 yr=10 3-5 yr= 7 5-10 yr= 3 10+ yr= 0	High=10 Med=5 Low=0	Poor =10 Ave =5 Great =0	<2 yr=10 5 yr= 5 10 yr= 2 20 yr= 0	Priority	<\$10K=1 <\$100K=2 >100K=3	
Building System	General Description	Recommendation	Useful Life	EHS Concern	Func. Cond.	ROI	Total Points	Proj. Cost	Cost Est.
Electrical Other	The public address (PA) system is in poor condition and beyond its expected usable life. A planned upgrade is scheduled for 2022-2023.	The District should replace the PA system as scheduled.	9	10	9	0	28	2	\$20,000
Site Utilities	An aerial mount electric supply transformer is beyond its expected useful life.	The District should replace this unit with an isolated ground-mount transformer. The estimated cost includes isolation and District accommodation costs. The utility should cover the transformer expense.	9	9	9	0	27	1	\$8,500

Exterior Walls	Perform annual exterior wall inspection, preventative maintenance, and tri-annual corrective wall maintenance.	The District should annually inspect and correct wall deficiencies. This includes sealing, caulking, fixing open weeps, replacing flashing, and tuckpointing missing, deteriorated, and failed mortar.	8	8	9	2	27	1	\$8,500
Exterior Walls	There are missing junction box covers.	The District should replace the missing electrical covers.	10	8	9	0	27	1	\$300

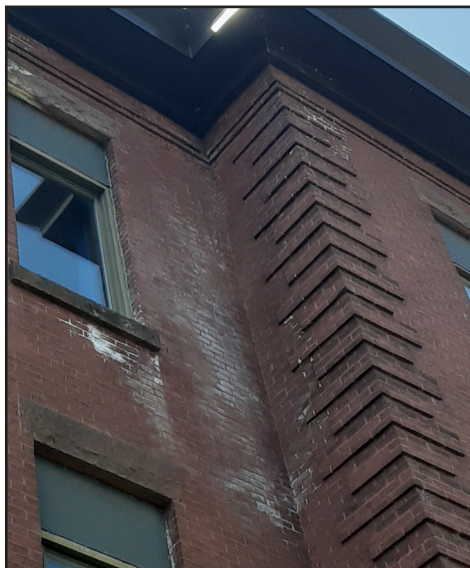
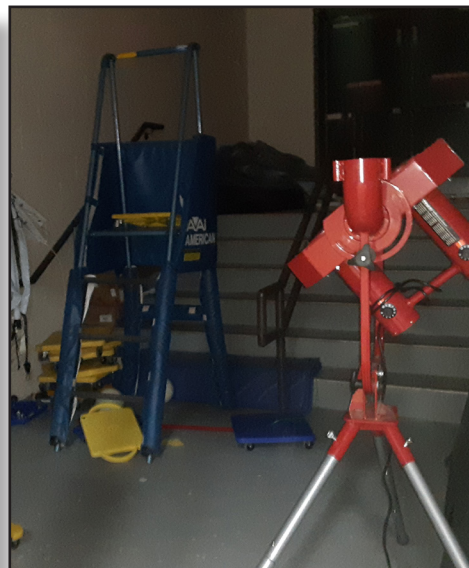
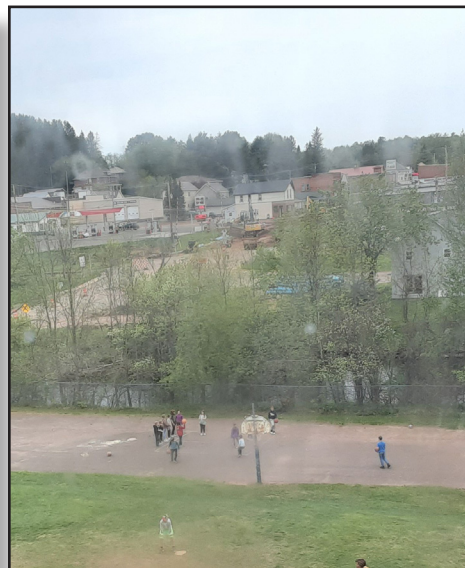
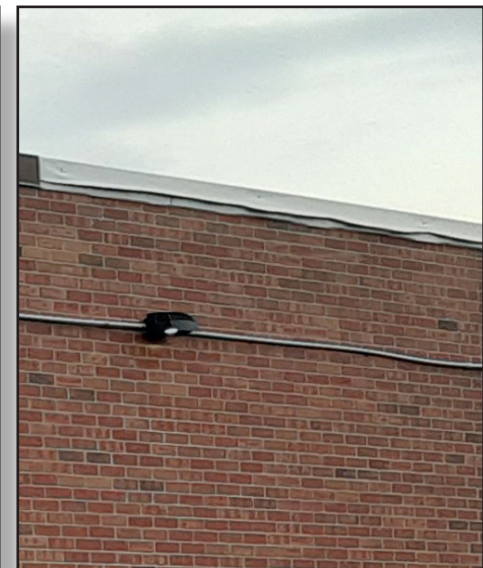
Facility Improvement Measures School District of Mellen			Project Recommendation Priority Order						
			<2 yr=10 3-5 yr= 7 5-10 yr= 3 10+ yr= 0	High=10 Med=5 Low=0	Poor =10 Ave =5 Great =0	<2 yr=10 5 yr= 5 10 yr= 2 20 yr= 0	Priority	<\$10K=1 <\$100K=2 >100K=3	
Building System	General Description	Recommendation	Useful Life	EHS Concern	Func. Cond.	ROI	Total Points	Proj. Cost	Cost Est.
Exterior Walls	There is effervescence on the exterior walls suggesting water retention. This is due to failed waterproofing, flashing, and lintels.	The District should replace or repair the flashing and lintels, caulk and seal to waterproof, and keep the weeps open.	9	7	10	0	26	3	\$250,000
Interior Other	There are obstructions in the corridors.	The District should store materials in appropriate storage areas.	7	10	9	0	26	2	\$500
Electrical Other	There are minimal exterior door controls and alarms. This is a planned upgrade scheduled for 2023-2024.	The District should upgrade Doors B, C, G, and H as scheduled.	8	10	8	0	26	2	\$20,000

Site/Civil (General)	The River Lot (north) is due for replacement. This is a planned upgrade scheduled for 2024-2025.	The District should replace this lot as scheduled and move the fence back to add more parking at that time.	8	9	8	0	25	2	\$18,000
Exterior Roofing	The metal roof edge flashings are missing.	The District should anchor and seal the roof edge and replace all flashings.	9	4	10	2	25	1	\$4,800

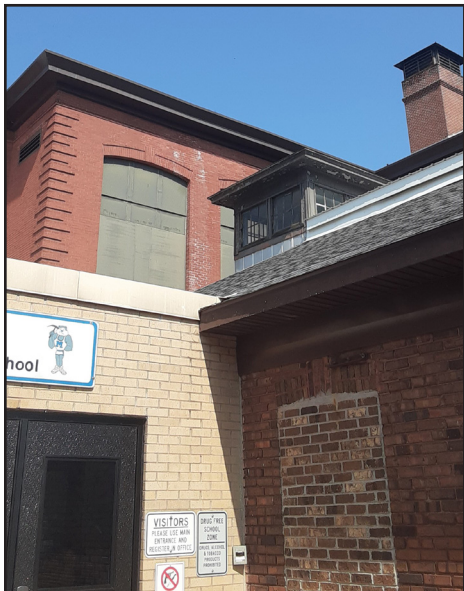
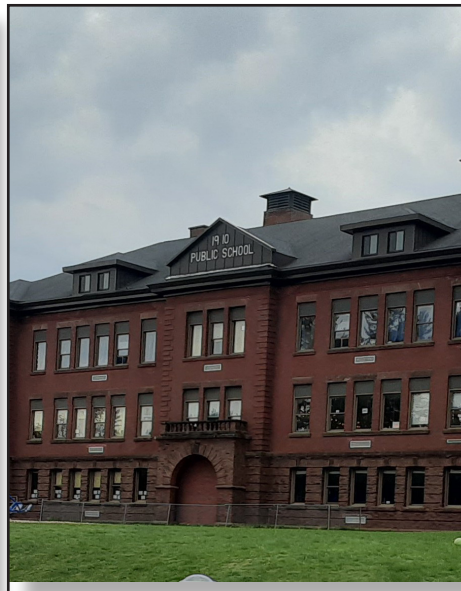
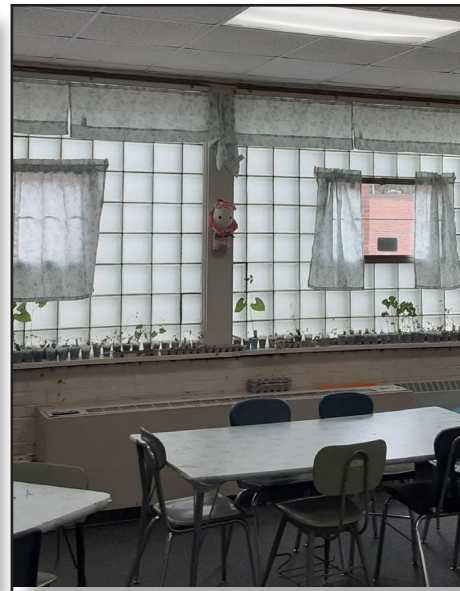
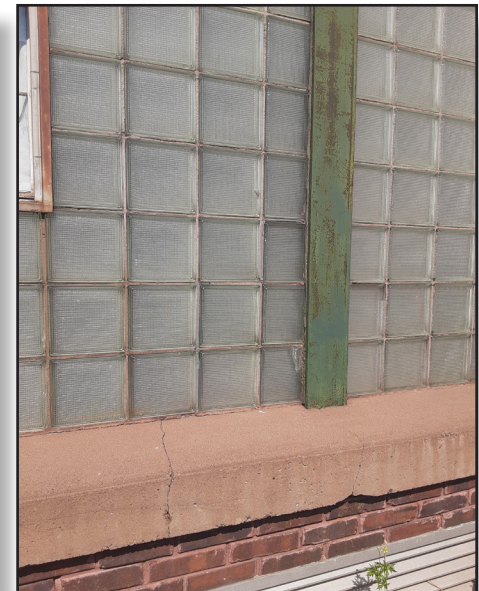
Facility Improvement Measures School District of Mellen			Project Recommendation Priority Order							
			<2 yr=10 3-5 yr= 7 5-10 yr= 3 10+ yr= 0	High=10 Med=5 Low=0	Poor =10 Ave =5 Great =0	<2 yr=10 5 yr= 5 10 yr= 2 20 yr= 0	Priority	<\$10K=1 <\$100K=2 >100K=3		
Building System	General Description	Recommendation	Useful Life	EHS Concern	Func. Cond.	ROI	Total Points	Proj. Cost	Cost Est.	
Exterior Roofing	The roof above Door H needs to be replaced. It was planned for replacement in 2022-2023 using fund balance dollars.	The District should replace it as scheduled and switch it from a ballasted roof to an EDPM-adhered membrane roof.	10	6	9	0	25	1	\$8,000	
Exterior Walls	The exterior walls have cracked brick, stone, and mortar. Brick replacement and tuckpointing are needed in many areas. Cracked lentils, coping, and caps are common.	The District should remove or replace the failed bricks and tuckpoint mortar. It should also replace cracked lentils, coping, and caps.	9	7	9	0	25	3	\$355,000

Exterior Doors/Windows	There are leaking and failing glass block windows in Rooms 107 and 111. They are planned for replacement in 2027-2028.	The District should replace the glass block windows as scheduled.	9	8	8	0	25	2	\$15,000	
Restrooms	The second-floor restroom is beyond its expected useful life. It is planned for renovation in 2025-2026.	The District should renovate the restrooms as scheduled, including replacing surfaces and fixtures.	9	7	9	0	25	2	\$75,000

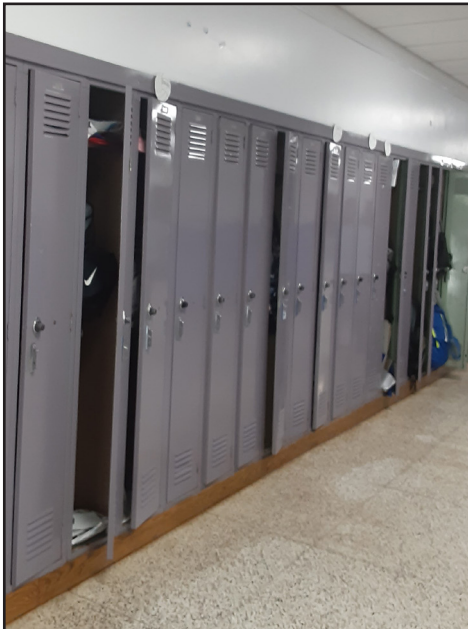
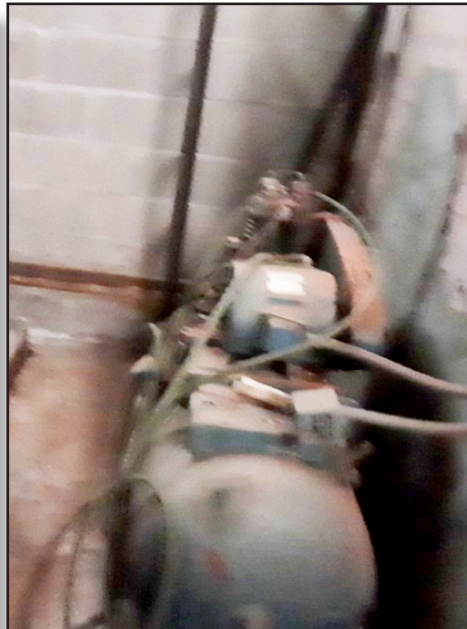
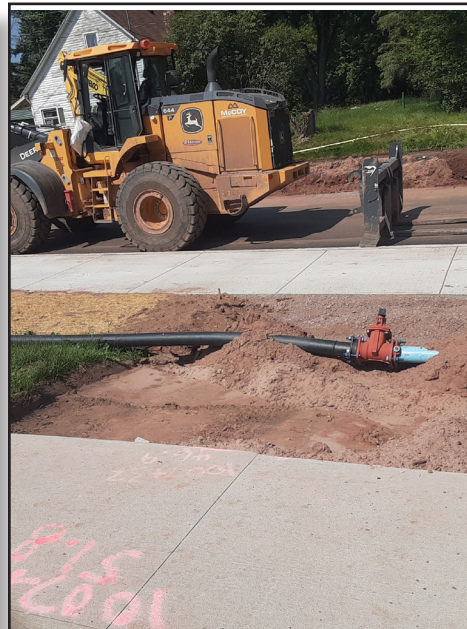
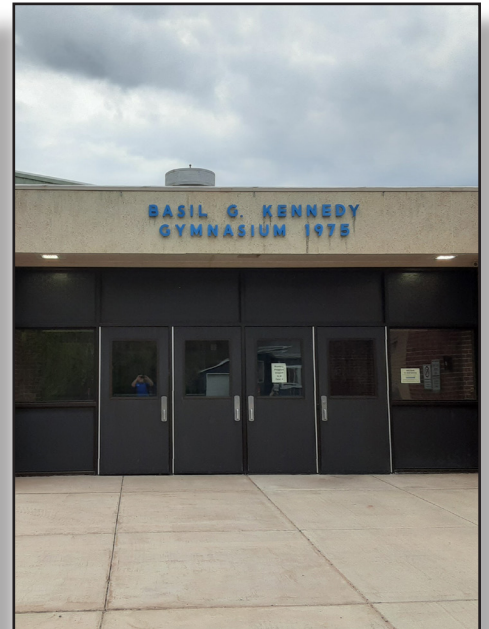
Facility Improvement Measures School District of Mellen			Project Recommendation Priority Order						
			<2 yr=10 3-5 yr= 7 5-10 yr= 3 10+ yr= 0	High=10 Med=5 Low=0	Poor =10 Ave =5 Great =0	<2 yr=10 5 yr= 5 10 yr= 2 20 yr= 0	Priority	<\$10K=1 <\$100K=2 >100K=3	
Building System	General Description	Recommendation	Useful Life	EHS Concern	Func. Cond.	ROI	Total Points	Proj. Cost	Cost Est.
Interior Other	Middle and High School lockers are beyond the expected useful life and are planned for replacement in 2027-2028.	The District should replace the lockers as scheduled.	9	7	9	0	25	2	\$42,000
HVAC Controls	There is a decommissioned pneumatic compressor in the boiler room.	The District should remove and recycle it.	10	5	10	0	25	1	\$100
Site Utilities	Water main supply issues have occurred frequently in the past.	The District should replace the new main water supply after the street work is complete.	9	7	8	0	24	2	\$15,000

Exterior Roofing	The roof security fence is open.	The District should close and secure it to restrict roof access.	4	10	10	0	24	1	\$500
Exterior Doors/Windows	Secure entrance improvements are needed and are scheduled for replacement in 2022-2023.	The District should perform the secure entrance modifications as scheduled.	7	10	7	0	24	2	\$70,000

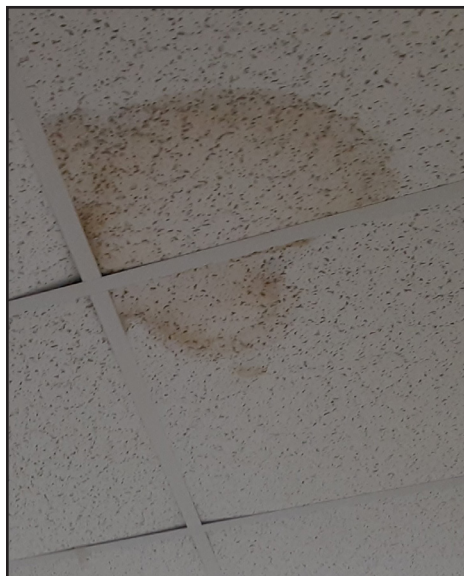
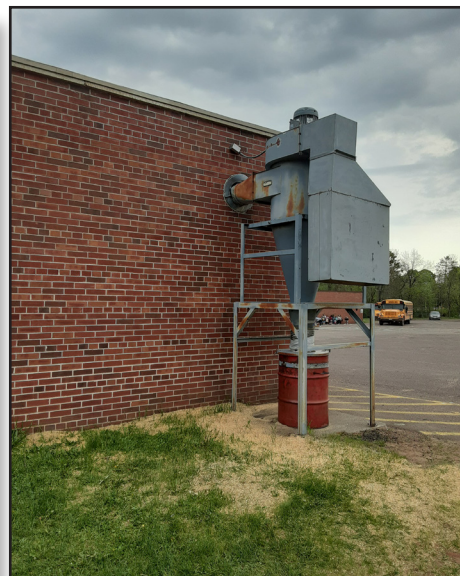
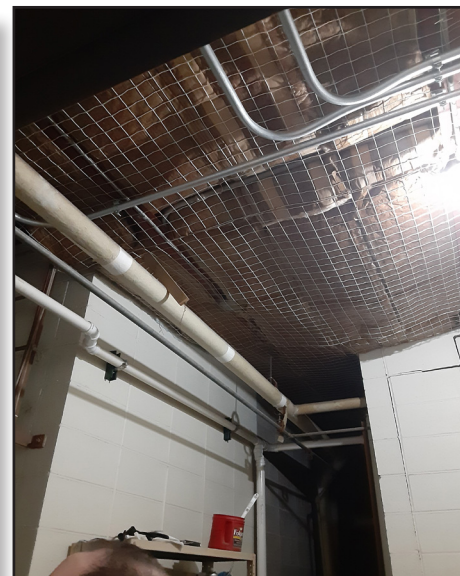
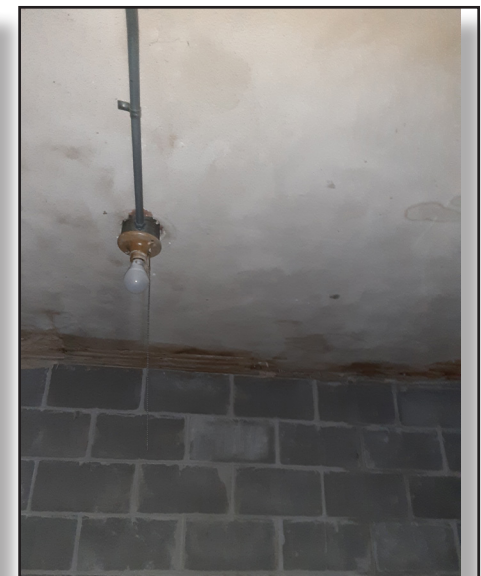
Facility Improvement Measures School District of Mellen			Project Recommendation Priority Order						
			<2 yr=10 3-5 yr= 7 5-10 yr= 3 10+ yr= 0	High=10 Med=5 Low=0	Poor =10 Ave =5 Great =0	<2 yr=10 5 yr= 5 10 yr= 2 20 yr= 0	Priority	<\$10K=1 <\$100K=2 >100K=3	
Building System	General Description	Recommendation	Useful Life	EHS Concern	Func. Cond.	ROI	Total Points	Proj. Cost	Cost Est.
Interior Other	The stage backdrop is in poor condition and is planned for replacement in 2029-2030.	The District should replace the stage backdrop as scheduled.	9	6	9	0	24	2	\$15,000
HVAC Controls	The pneumatic valves and actuators in the heating system are leaking and non-functional. They are causing stained ceiling tiles and occupant discomfort and are planned for replacement in 2026-2027.	The District should replace the pneumatic valves and actuators as scheduled.	9	6	9	0	24	3	\$85,000
Exhausts	The Tech-Ed dust collector is reaching the end of its useful life.	The District should plan for a replacement.	9	7	8	0	24	2	\$8,000

Refrigeration	The kitchen freezer and storage area are beyond their expected useful life.	The District should plan for renovations concentrating on the interior surfaces, such as the ceiling, walls, and floor.	9	7	8	0	24	2	\$16,000

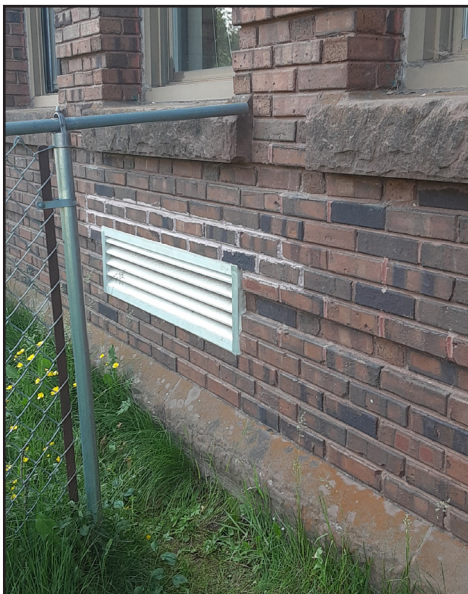
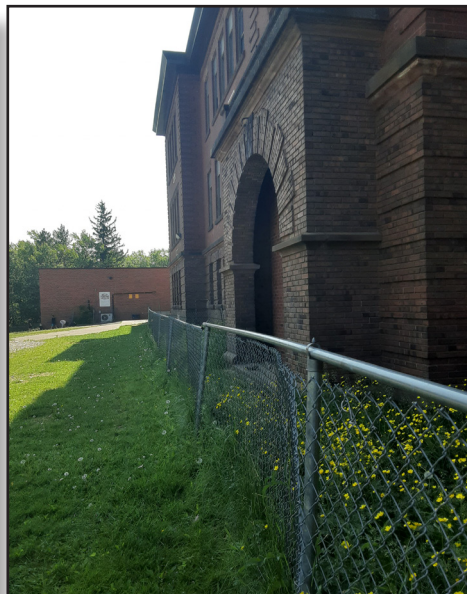
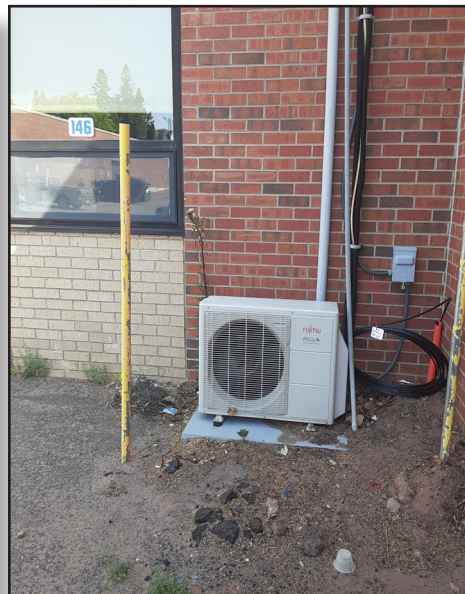
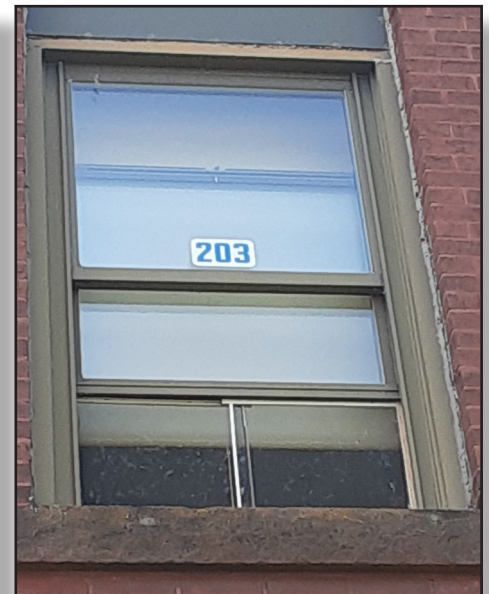
Facility Improvement Measures School District of Mellen			Project Recommendation Priority Order						
			<2 yr=10 3-5 yr= 7 5-10 yr= 3 10+ yr= 0	High=10 Med=5 Low=0	Poor =10 Ave =5 Great =0	<2 yr=10 5 yr= 5 10 yr= 2 20 yr= 0	Priority	<\$10K=1 <\$100K=2 >100K=3	
Building System	General Description	Recommendation	Useful Life	EHS Concern	Func. Cond.	ROI	Total Points	Proj. Cost	Cost Est.
Site/Civil (General)	There is open and bent isolation fencing along the north front side of the original building.	The District should repair and secure fencing. More decorative fencing would pair well with the historic look of the north side.	6	8	9	0	23	1	\$1,200
Site/Civil (General)	The area around the DX condenser units is open and missing a barrier fence.	The District should repair and replace fencing around the units.	6	8	9	0	23	1	\$750
Exterior Doors/Windows	There are no safety barriers on windows that open on the second and third floors.	The District plans to add safety grates to the third-floor windows in 2023. It should consider adding security screens to all opening windows.	5	10	8	0	23	2	\$12,500

Exterior Doors/Windows	Room 112 conference room windows need to be replaced. They are planned for replacement in 2024-2025.	The District should replace the conference room windows as scheduled.	8	7	8	0	23	2	\$15,500

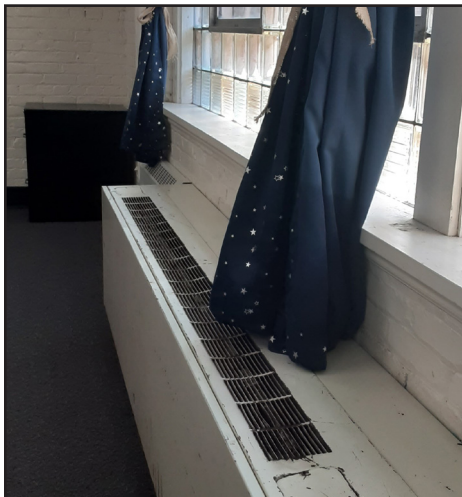
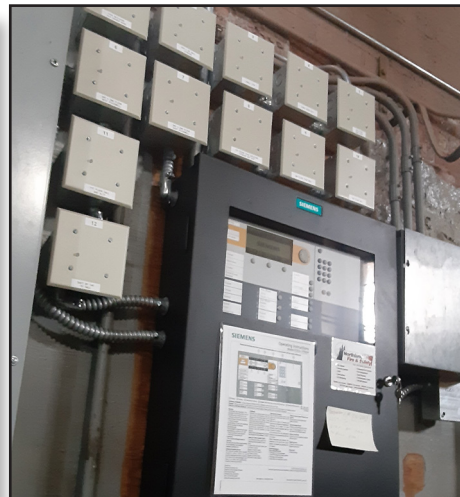
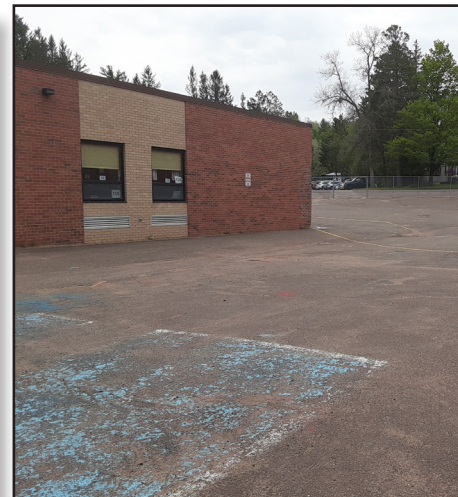
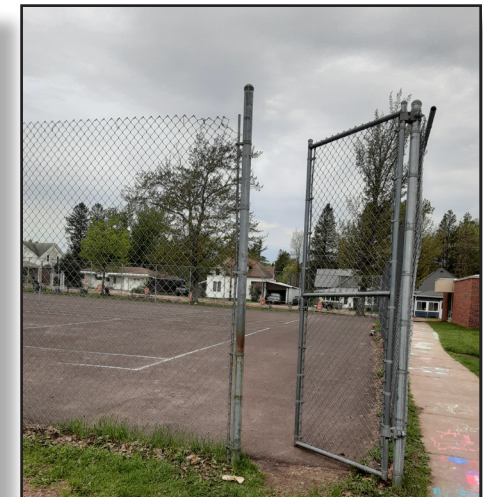
Facility Improvement Measures South Elementary School			Project Recommendation Priority Order						
			<2 yr=10 3-5 yr= 7 5-10 yr= 3 10+ yr= 0	High=10 Med=5 Low=0	Poor =10 Ave =5 Great =0	<2 yr=10 5 yr= 5 10 yr= 2 20 yr= 0	Priority	<\$10K=1 <\$100K=2 >100K=3	
Building System	General Description	Recommendation	Useful Life	EHS Concern	Func. Cond.	ROI	Total Points	Proj. Cost	Cost Est.
HVAC Air Distribution	The unit ventilators are reaching the end of their expected useful life.	The District should inventory, prioritize, and schedule replacements and consider lowered ceilings with ducted demand control ventilation.	7	8	8	0	23	3	\$150,000
Electrical Other	The fire panel in the boiler room is reaching the end of its expected useful life and is planned for replacement in 2029-2030.	The District should upgrade the fire panel as scheduled.	7	8	8	0	23	3	\$120,000
Site/Civil (General)	The Fayette parking area (south) is congested, based on staff feedback. The bus and student drop-off areas need improvement. This is planned for replacement in 2024-2025.	The District should improve the parking plan as scheduled and mark the drop-off areas after the street work is complete.	8	7	7	0	22	2	\$75,000

Site/Civil (General)	The outdoor court fencing is bent and missing the top support rails.	The District should replace the missing top rails, realign the fence posts, and repair the gates.	5	9	8	0	22	1	\$5,500

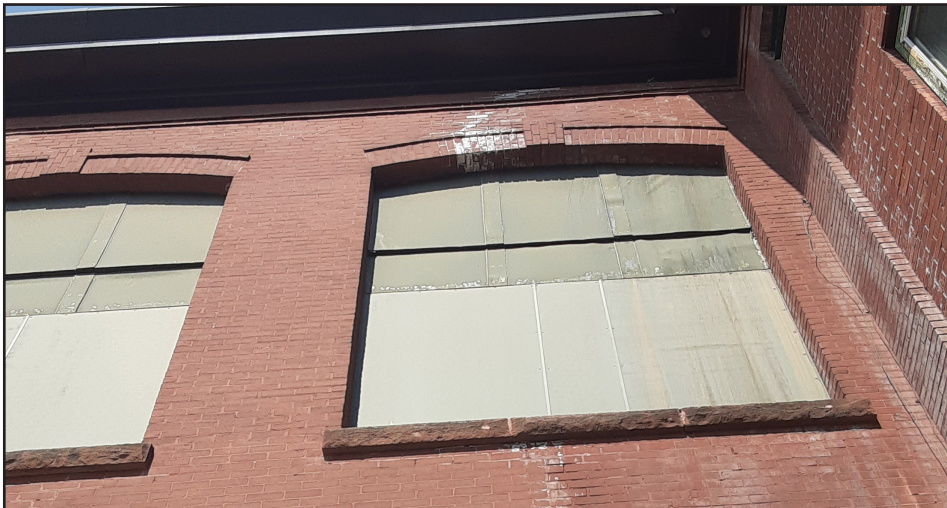
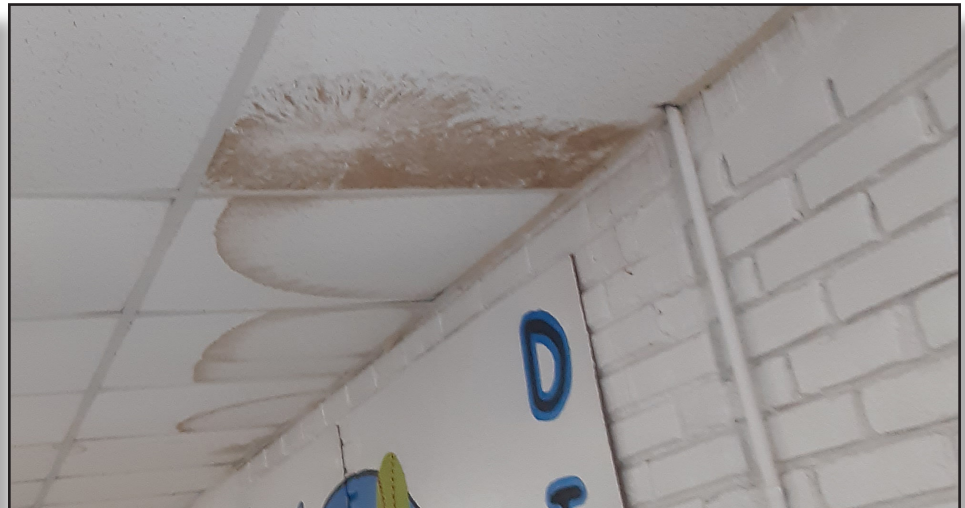
Facility Improvement Measures South Elementary School			Project Recommendation Priority Order						
			<2 yr=10 3-5 yr= 7 5-10 yr= 3 10+ yr= 0	High=10 Med=5 Low=0	Poor =10 Ave =5 Great =0	<2 yr=10 5 yr= 5 10 yr= 2 20 yr= 0	Priority	<\$10K=1 <\$100K=2 >100K=3	
Building System	General Description	Recommendation	Useful Life	EHS Concern	Func. Cond.	ROI	Total Points	Proj. Cost	Cost Est.
Exterior Roofing	The elementary and LMC roof sections need replacement and are planned for 2024-2025.	The District should replace the roof sections as scheduled and consider an earlier replacement if funding is available.	8	6	8	0	22	3	\$115,000
Exterior Roofing	The office and high school hallway roof sections need replacement and are planned for 2024-2025.	The District should replace the roof sections as scheduled and consider an earlier replacement if funding is available.	8	6	8	0	22	3	\$125,000
Exterior Walls	There are rough panels over the large windows on the upper floors.	The District should replace with spandrel glass, insulated panels, or enclose the brick face as done in other areas.	7	5	10	0	22	3	\$85,000

Ceilings	Many acoustic ceiling tiles (ACT) are stained from roof, valve, and infiltration leaks.	The District should resolve the leak and replace the ceiling. Doing a spot or target tile replacement would provide a quick aesthetic improvement.	8	6	8	0	22	2	\$12,000

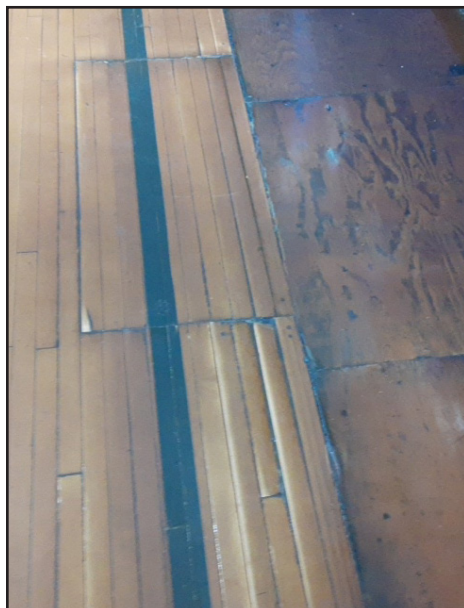
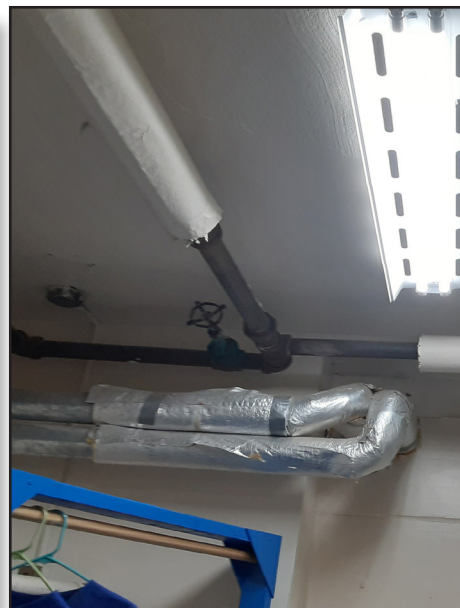
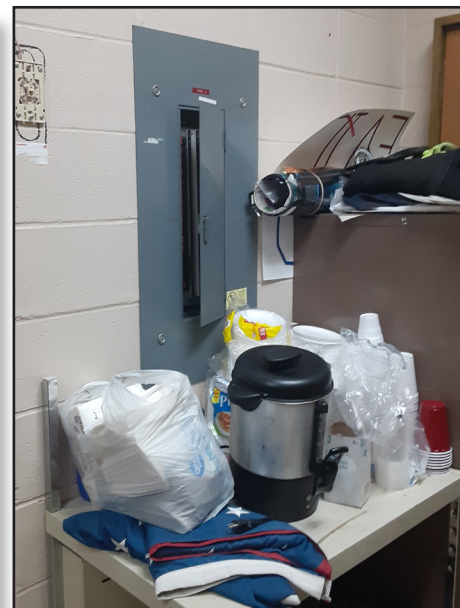
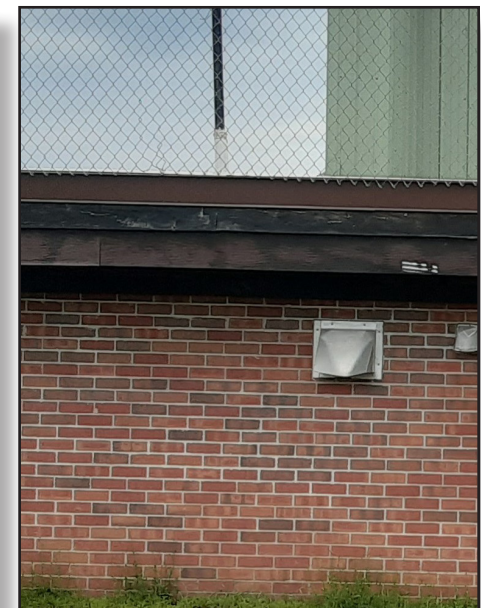
Facility Improvement Measures School District of Mellen			Project Recommendation Priority Order						
			<2 yr=10 3-5 yr= 7 5-10 yr= 3 10+ yr= 0	High=10 Med=5 Low=0	Poor =10 Ave =5 Great =0	<2 yr=10 5 yr= 5 10 yr= 2 20 yr= 0	Priority	<\$10K=1 <\$100K=2 >100K=3	
Building System	General Description	Recommendation	Useful Life	EHS Concern	Func. Cond.	ROI	Total Points	Proj. Cost	Cost Est.
Flooring	The small gym/cafeteria floor is deteriorated with rough edges. It is planned for replacement in 2026-2027.	The District should replace the wood floor as scheduled. The floor type will impact project costs. The District should consider replacement as part of a more extensive renovation.	8	6	8	0	22	2	\$15,000
HVAC Piping	There is missing and loose pipe/valve insulation.	The District should replace and repair missing and loose insulation.	7	5	5	5	22	1	\$1,000
Electrical Distribution	Access to the electrical panels is blocked.	The District should remove materials from the electrical panel areas and mechanical/electrical rooms to provide the required clearance around equipment.	5	10	7	0	22	1	\$1,000

Exterior Walls	There is deteriorating wood fascia and soffit on the south side of the building.	The District should paint or replace it with a finished standard-color metal.	9	3	9	0	21	1	\$2,800

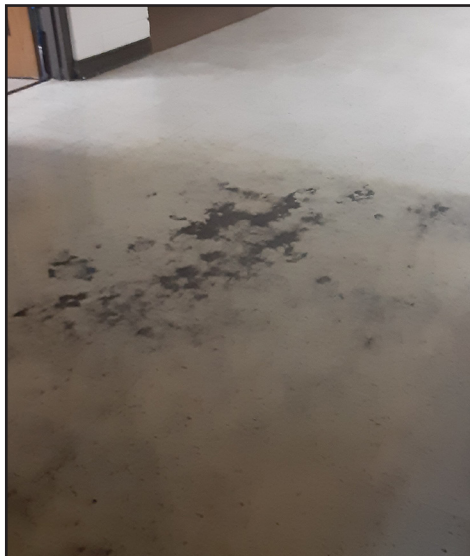
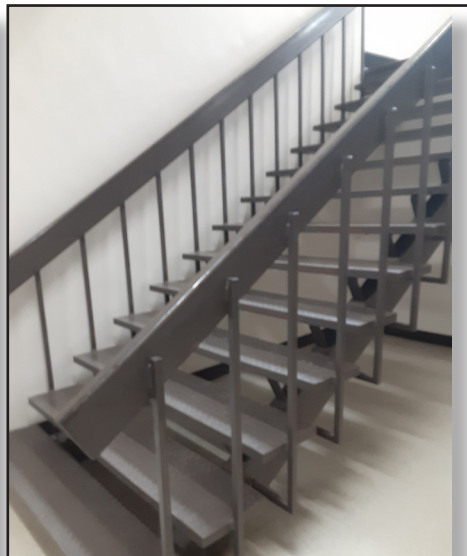
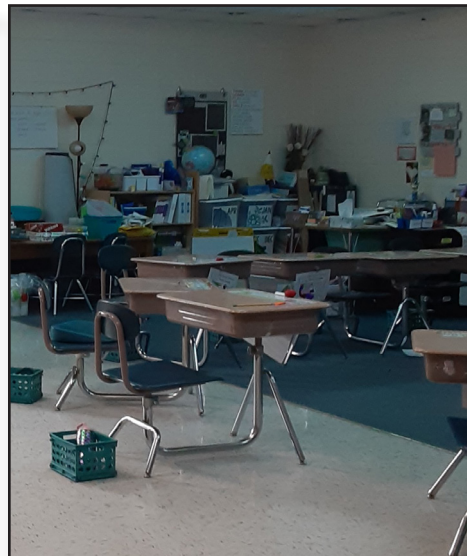
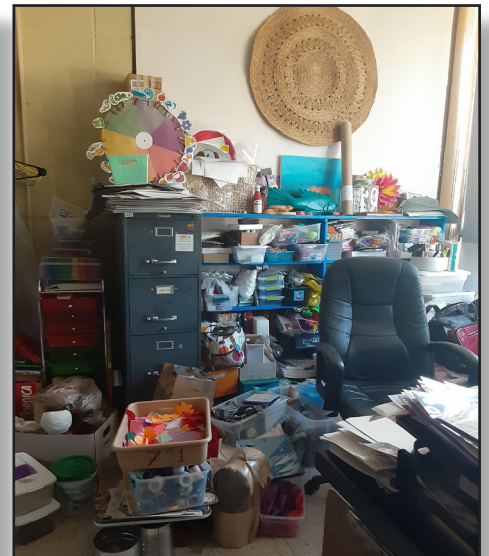
Facility Improvement Measures School District of Mellen			Project Recommendation Priority Order						
			<2 yr=10 3-5 yr= 7 5-10 yr= 3 10+ yr= 0	High=10 Med=5 Low=0	Poor =10 Ave =5 Great =0	<2 yr=10 5 yr= 5 10 yr= 2 20 yr= 0	Priority	<\$10K=1 <\$100K=2 >100K=3	
Building System	General Description	Recommendation	Useful Life	EHS Concern	Func. Cond.	ROI	Total Points	Proj. Cost	Cost Est.
Flooring	The VCT flooring is worn and in need of replacement. Inconsistent floor covering replacements were made in the past.	The District should standardize vinyl tile, epoxy coating, and carpet square types and colors and replace worn or damaged flooring.	7	7	7	0	21	1	\$30,000
Stairs	Handrail openings are wider than a six-inch sphere and are not compliant.	The District should add guards, replace, or modify the handrails per code requirements.	5	8	8	0	21	2	\$28,000
Toilet Rooms	The District office restroom is beyond its expected useful life and is planned for renovation in 2028-2029.	The District should renovate the restroom surfaces and fixtures as scheduled.	7	6	8	0	21	1	\$12,000

Interior Other	The classrooms are cluttered with miscellaneous items.	The District should add cabinets or storage units as needed for proper storage and discard or recycle unused items.	7	6	8	0	21	2	\$15,000

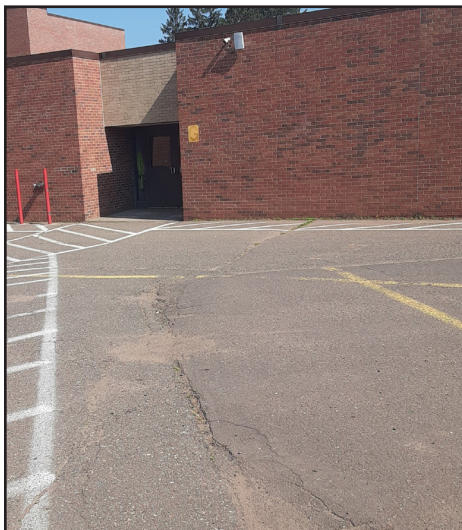
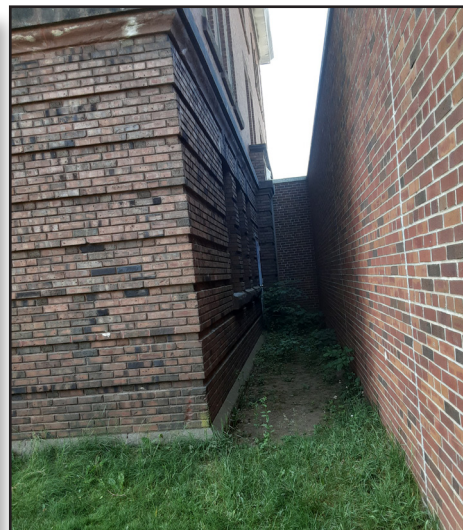
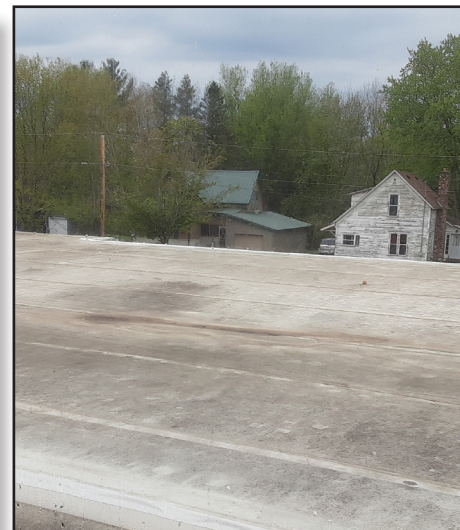
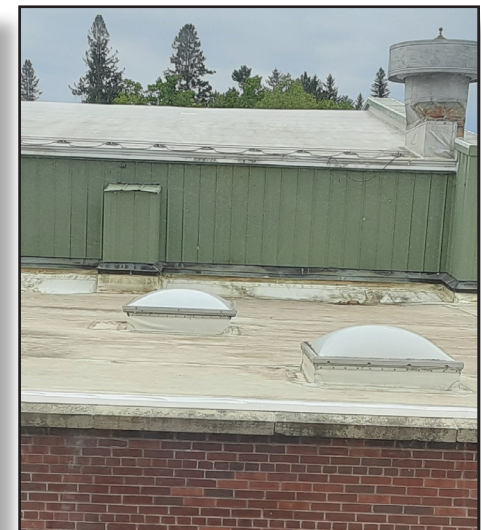
Facility Improvement Measures School District of Mellen			Project Recommendation Priority Order						
			<2 yr=10 3-5 yr= 7 5-10 yr= 3 10+ yr= 0	High=10 Med=5 Low=0	Poor =10 Ave =5 Great =0	<2 yr=10 5 yr= 5 10 yr= 2 20 yr= 0	Priority	<\$10K=1 <\$100K=2 >100K=3	
Building System	General Description	Recommendation	Useful Life	EHS Concern	Func. Cond.	ROI	Total Points	Proj. Cost	Cost Est.
Site/Civil (General)	While the asphalt is in good condition, some areas have longitudinal and transverse cracks.	The District should crack clean and fill these cracks.	7	5	6	2	20	1	\$1,500
Site Landscaping	The building, turf, and hardscape transitions are in poor shape.	The District should install a permeable (traffic bond or gravel) edge transition between the building and turf, slope it away from the building, and cover it with crushed decorative granite.	5	5	9	1	20	1	\$8,000
Exterior Roofing	The roof decking under the membrane/ base needs work in several areas.	The District should increase the frequency of the roof replacement cycle and perform seasonal inspections and maintenance.	7	5	8	0	20	2	\$22,000

Exterior Walls	The big gym exterior walls need to be painted. They are planned for painting in 2024-2025.	The District should paint the gym exterior as scheduled.	8	4	8	0	20	1	\$7,500

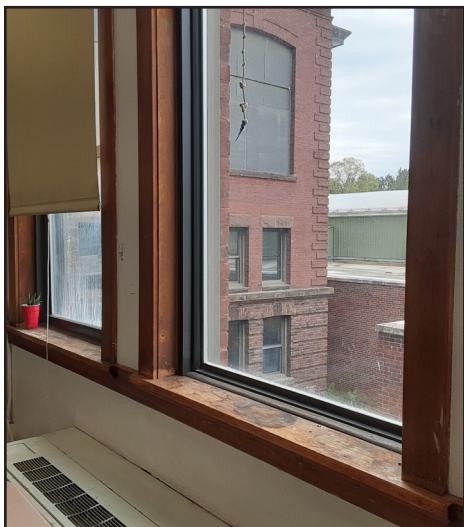
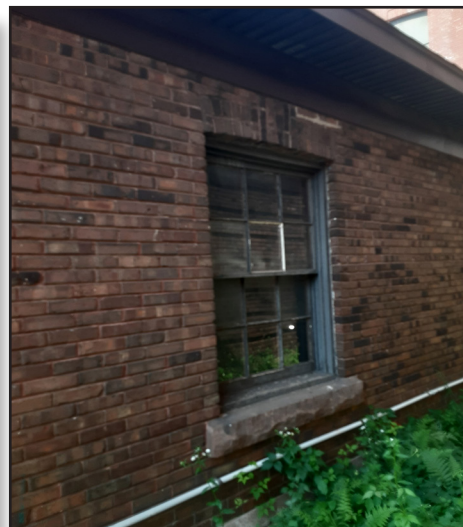
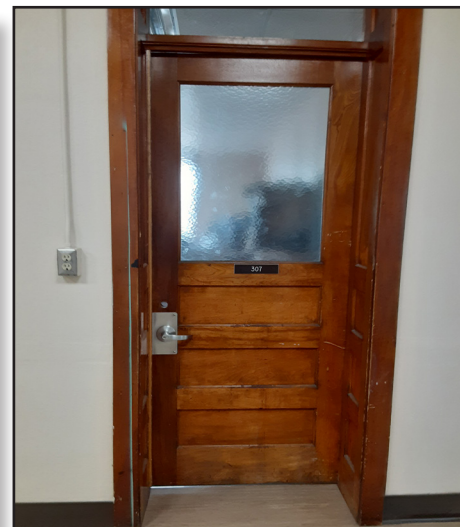
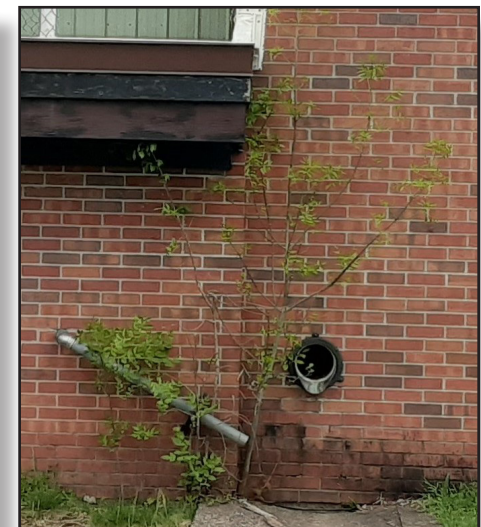
Facility Improvement Measures School District of Mellen			Project Recommendation Priority Order						
			<2 yr=10 3-5 yr= 7 5-10 yr= 3 10+ yr= 0	High=10 Med=5 Low=0	Poor =10 Ave =5 Great =0	<2 yr=10 5 yr= 5 10 yr= 2 20 yr= 0	Priority	<\$10K=1 <\$100K=2 >100K=3	
Building System	General Description	Recommendation	Useful Life	EHS Concern	Func. Cond.	ROI	Total Points	Proj. Cost	Cost Est.
Exterior Walls	The lettering for the District office needs to be updated. It is planned for 2025-2026.	The District should update the lettering as scheduled.	8	4	8	0	20	1	\$5,000
Exterior Walls	The wall vent discharge hood is bent and rusted.	The District should repair and paint or replace the wall vent discharge hood.	8	5	7	0	20	1	\$300
Exterior Doors/ Windows	The wood window frames are stained.	The District should paint or remove the stains and finish.	6	5	9	0	20	2	\$18,000
Exterior Doors/ Windows	The boiler room windows are failed.	The District should replace it with a more durable frame and glazing.	6	5	9	0	20	2	\$18,000

Interior Doors	There are many stained and worn wood doors in the original building.	The District should refinish, paint, or replace.	8	5	7	0	20	2	\$18,000
Site Landscaping	Routine landscaping maintenance and replacement are needed.	The District should remove vegetation around building perimeters, fencing, hardscape surface edges, and utility supply areas. It should set slope standards per location and annually inspect and correct to standard.	7	3	7	2	19	1	\$5,000

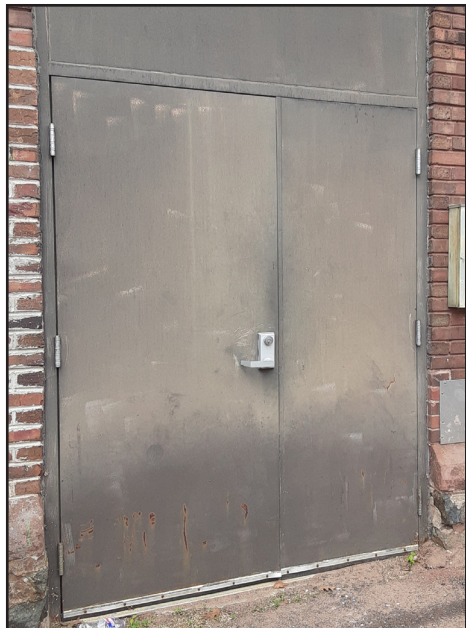
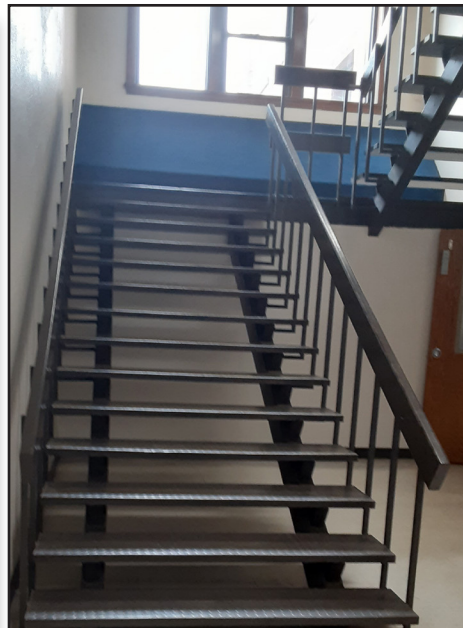
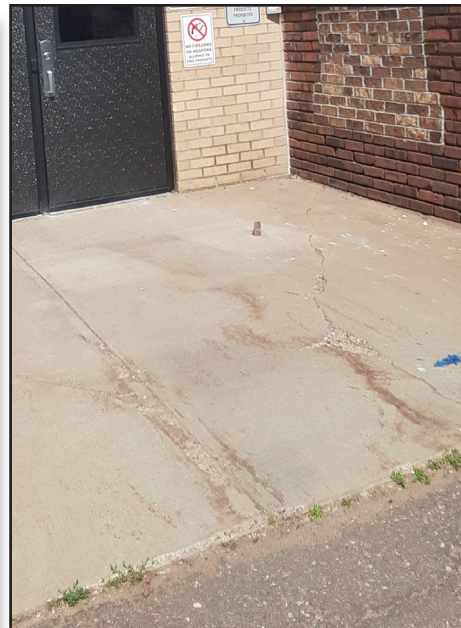
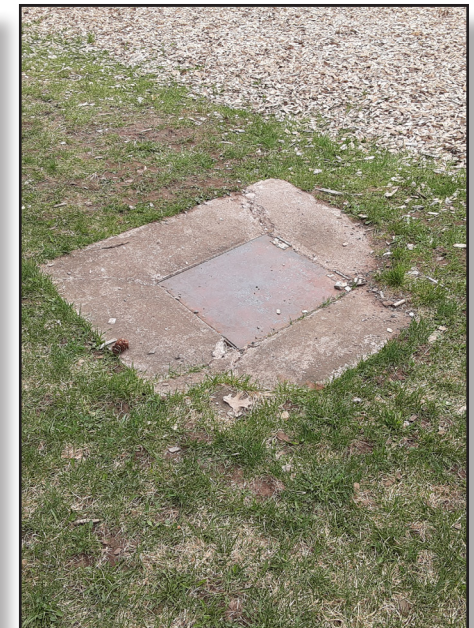
Facility Improvement Measures School District of Mellen			Project Recommendation Priority Order						
			<2 yr=10 3-5 yr= 7 5-10 yr= 3 10+ yr= 0	High=10 Med=5 Low=0	Poor =10 Ave =5 Great =0	<2 yr=10 5 yr= 5 10 yr= 2 20 yr= 0	Priority	<\$10K=1 <\$100K=2 >100K=3	
Building System	General Description	Recommendation	Useful Life	EHS Concern	Func. Cond.	ROI	Total Points	Proj. Cost	Cost Est.
Exterior Doors/Windows	The exterior exit doors are faded, scratched, dented, and missing weatherstripping.	The District should inventory, prioritize, and schedule repairs or replacements.	8	3	8	0	19	2	\$35,000
Stairs	The handrails do not extend beyond the bottom or top stair risers.	The District should extend the handrails to the required length by code.	5	7	7	0	19	2	\$16,000
Site/Civil (General)	There is a cracked exit door landing and a concrete walk slab.	The District should replace the cracked walk slab. Much of the west side concrete will be replaced with the 2023 street project.	7	5	6	0	18	1	\$4,200

Site/Civil (General)	There is cracked concrete below the grade access door pad.	The District should patch or replace and consider labeling access to identify the access door's purpose.	7	5	6	0	18	1	\$4,200

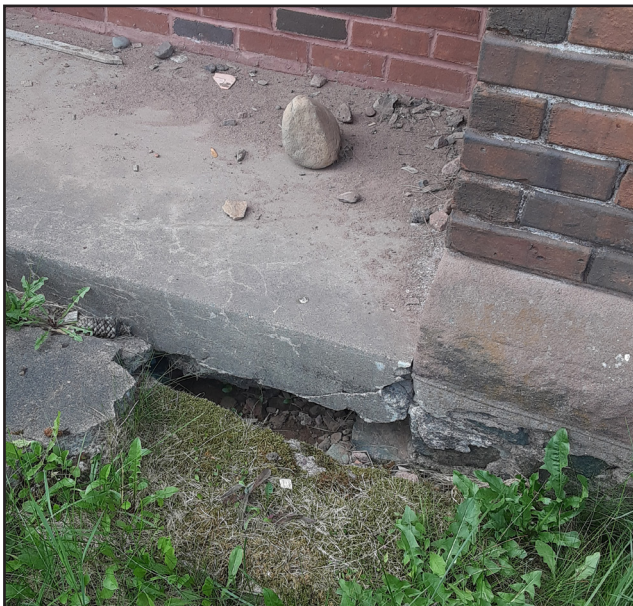
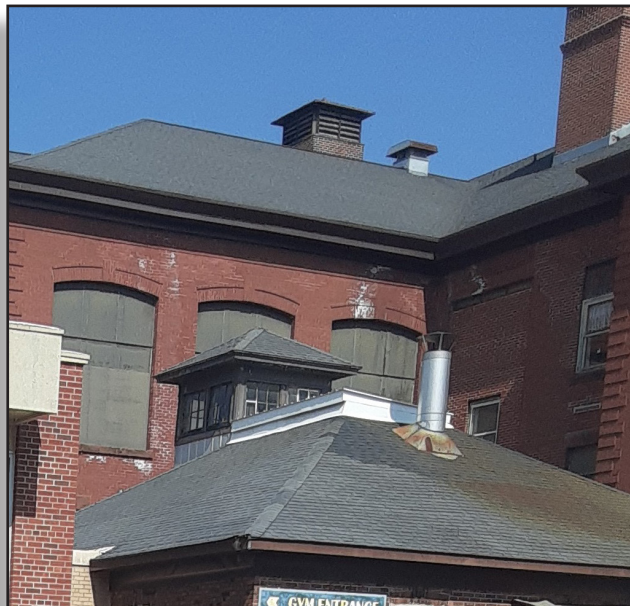
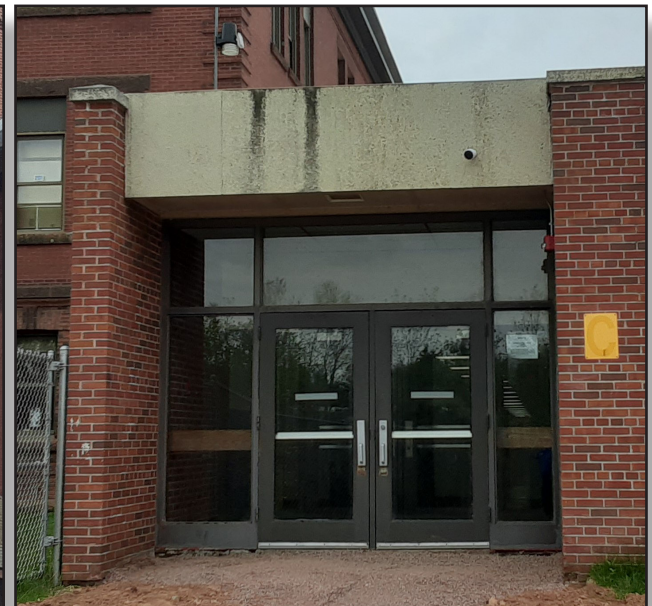
Facility Improvement Measures School District of Mellen			Project Recommendation Priority Order						
			<2 yr=10 3-5 yr= 7 5-10 yr= 3 10+ yr= 0	High=10 Med=5 Low=0	Poor =10 Ave =5 Great =0	<2 yr=10 5 yr= 5 10 yr= 2 20 yr= 0	Priority	<\$10K=1 <\$100K=2 >100K=3	
Building System	General Description	Recommendation	Useful Life	EHS Concern	Func. Cond.	ROI	Total Points	Proj. Cost	Cost Est.
Foundation	There is an open void under the foundation skirt on the north side of the original building.	The District should backfill with hydrostatic concrete to seal it from potential water/ice infiltration.	6	3	9	0	18	1	\$750
Exterior Roofing	Roof inspection, maintenance, and replacement are needed.	The District should inventory, schedule, and implement life cycle replacement for all roof sections, inspect seasonally, clean, and make corrections.	7	3	6	2	18	1	\$1,500
Exterior Roofing	The 1910 shingle plan is scheduled for roof replacement in 2027-2028.	The District should perform the roof replacement as scheduled and consider an earlier replacement if funding is available.	6	6	6	0	18	2	\$12,000

Exterior Walls	There is a stained stone facia on the west side of the building.	The District should clean and channel water flow to the drain system.	7	3	8	0	18	1	\$1,500
