FACILITY AUDIT SCHOOL DISTRICT OF MELLEN AUGUST 2023

PREPARED BY:
CESA 10 Facilities Management
725 W Park Avenue
Chippewa Falls, WI 54729
888-947-4701
<http://facilities.cesa10.org>

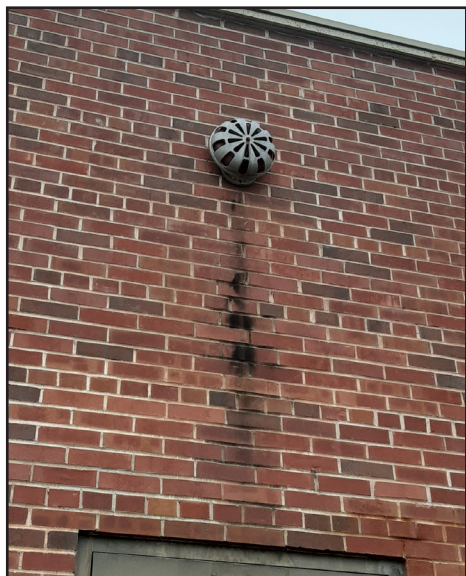
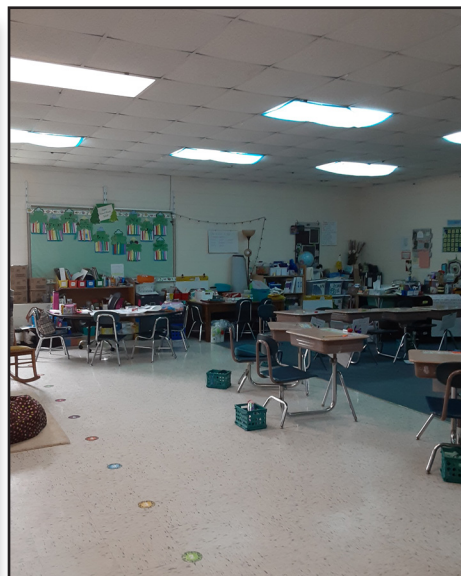
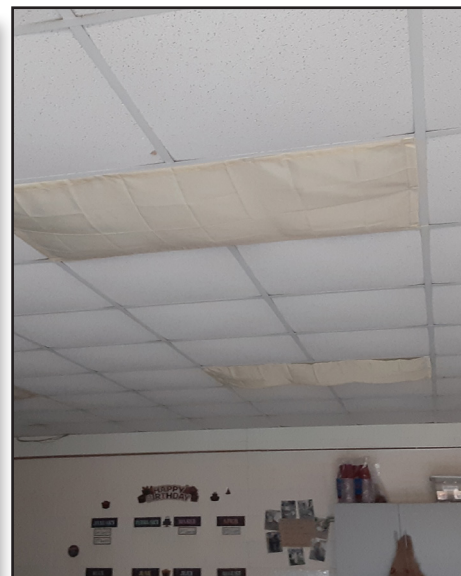
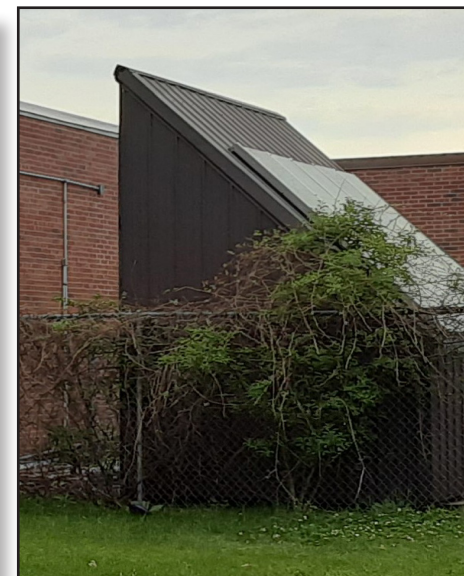
Facility Improvement Measures School District of Mellen			Project Recommendation Priority Order						
			<2 yr=10 3-5 yr= 7 5-10 yr= 3 10+ yr= 0	High=10 Med=5 Low=0	Poor =10 Ave =5 Great =0	<2 yr=10 5 yr= 5 10 yr= 2 20 yr= 0	Priority	<\$10K=1 <\$100K=2 >100K=3	
Building System	General Description	Recommendation	Useful Life	EHS Concern	Func. Cond.	ROI	Total Points	Proj. Cost	Cost Est.
Exterior Walls	There are stained brick walls in several areas.	The District should clean and channel water flow off of the walls.	7	3	8	0	18	1	\$1,000
Exterior Walls	There is a soiled decorative baluster balcony.	The District should clean and seal so all water and soil shed off the balcony.	7	3	8	0	18	1	\$1,000
Lighting	The LED lamp conversion from 2016 is aging. There are classrooms with minimal comfort and energy-saving controls and many overlit areas with fixtures covered to dim light.	The District should update lighting with LED fixtures, including dimming, daylight, and schedule controls. New wireless controls also offer this capability. The District should consider coordinating the lighting upgrades with the ceiling replacement.	4	4	5	5	18	3	\$110,000

Site Landscaping	There is invasive vegetation in the storage area.	The District should remove vegetation and treat it seasonally.	5	4	8	0	17	1	\$500

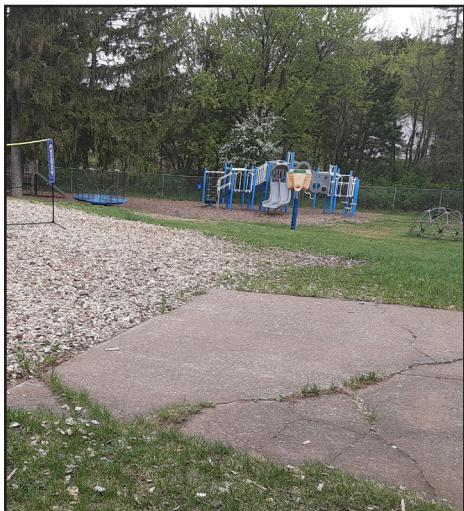
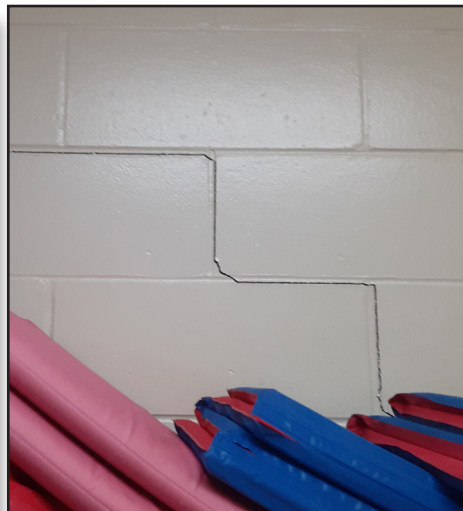
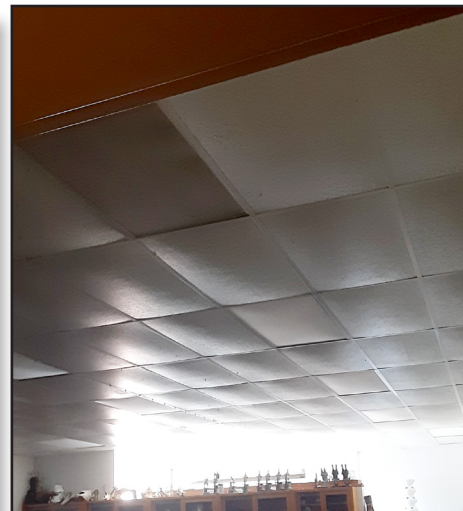
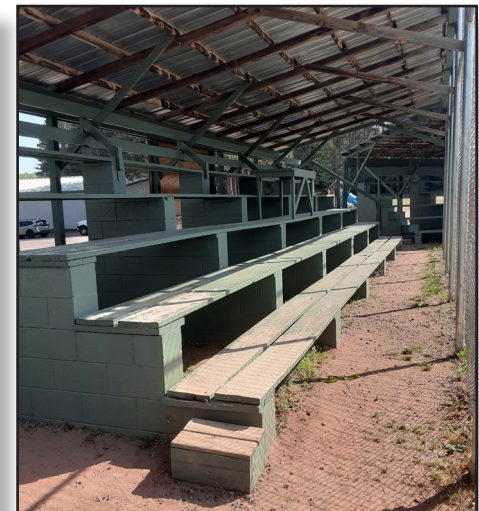
Facility Improvement Measures School District of Mellen			Project Recommendation Priority Order						
			<2 yr=10 3-5 yr= 7 5-10 yr= 3 10+ yr= 0	High=10 Med=5 Low=0	Poor =10 Ave =5 Great =0	<2 yr=10 5 yr= 5 10 yr= 2 20 yr= 0	Priority	<\$10K=1 <\$100K=2 >100K=3	
Building System	General Description	Recommendation	Useful Life	EHS Concern	Func. Cond.	ROI	Total Points	Proj. Cost	Cost Est.
Site Facilities	The playground fall areas require routine maintenance.	The District should maintain fall zone material every one to two years, remove decomposed material every five to seven years, and install edging or deep cut turf edge to retain the material in place.	6	6	5	0	17	1	\$2,500
Foundation	There are step cracks on the interior walls of the east addition.	The District should shore up the foundation to stabilize wall movements.	6	3	8	0	17	1	\$8,500
Ceilings	Many ACT tiles are bowed. CESA 10 suspects this is due to humidity.	The District should replace ceiling tiles after a standard has been set. It should consider doing it conjunction with the lighting control project.	6	5	6	0	17	2	\$38,000

Site Facilities	The bleachers are reaching the end of their useful life.	The District should plan for replacement in the next four to five years. The cost estimate is based on ADA-compliant aluminum bleachers.	5	5	6	0	16	2	\$12,000
